Haluzická tiesňava / Haluzice Gorge

MEZINÁRODNÝ
ROK LESOV • 2011

LESY SR
s.p. Banská Bystrica

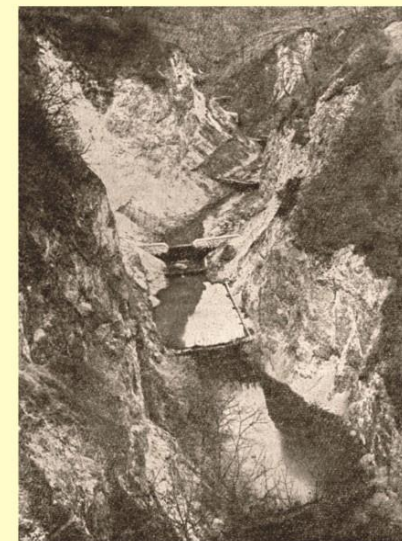
Haluzická strž po zahradení v roku 1927, foto: L. Skatula

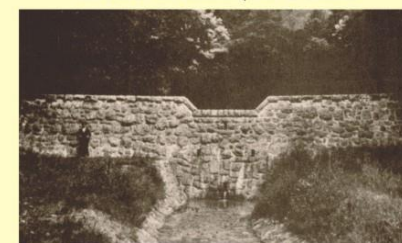
Záchytná prehrádzka z roku 1927, foto: L. Skatula

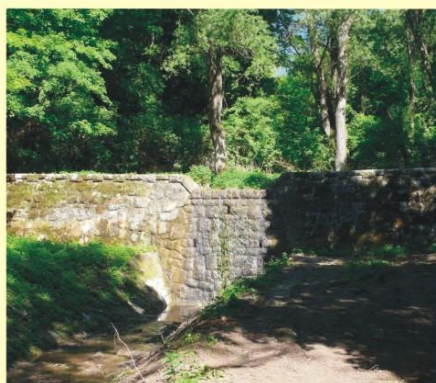
Záchytná prehrádzka v roku 2011

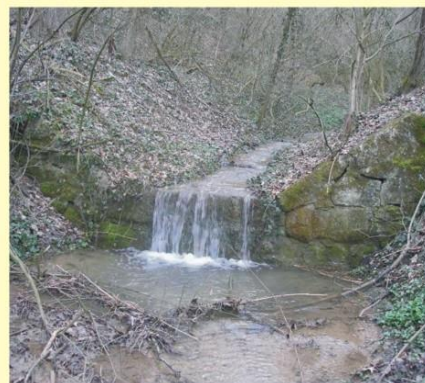
Kamenný stupeň č. 17

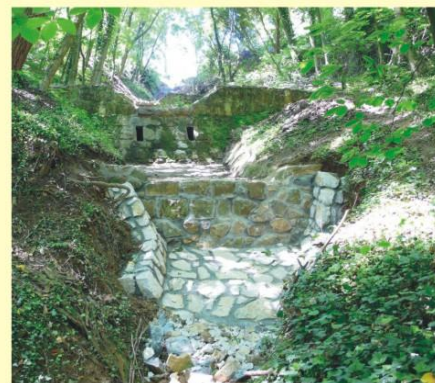
Kamenné prehrádzky v pravostrannej strži po oprave v r. 2011
